6.0 PRODUCTS & ASSEMBLY INFORMATION

Strata Plan LMS 4050 – The 501
501 Pacific Street, Vancouver B.C.

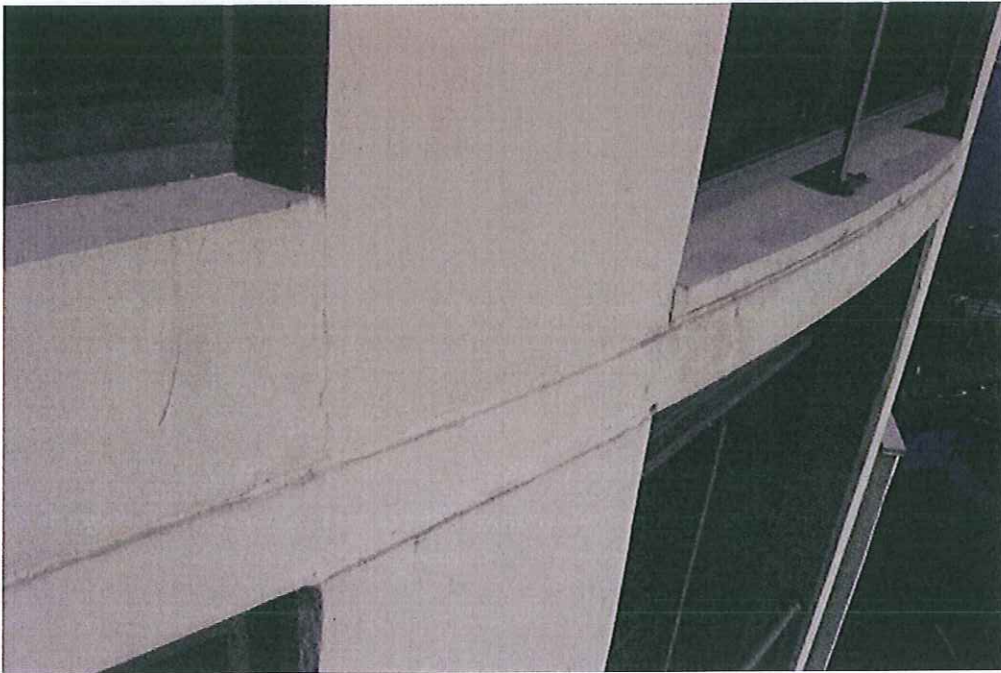
CONCRETE

The entire complex of The 501 has been constructed with cast-in-place concrete walls and slabs. Concrete is a strong, durable and versatile product, which is commonly used in the construction of modern buildings. It can be finished to give a variety of architectural appearances from patterned and coloured to exposed aggregate. The one thing common to all concrete is cracking, regardless of the surface finish or whether it is a wall or floor slab.

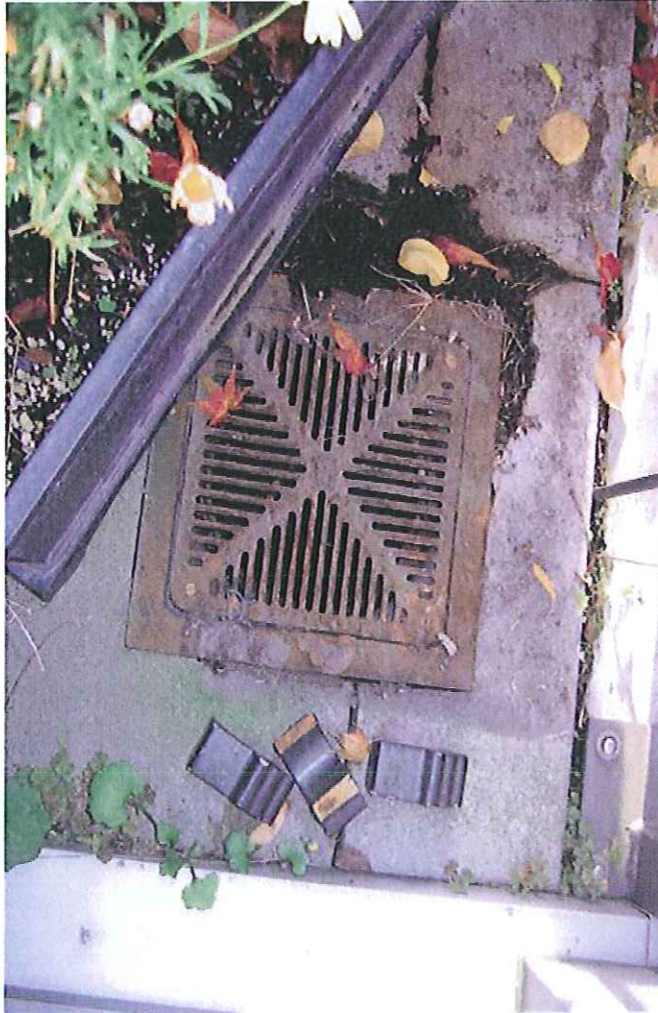
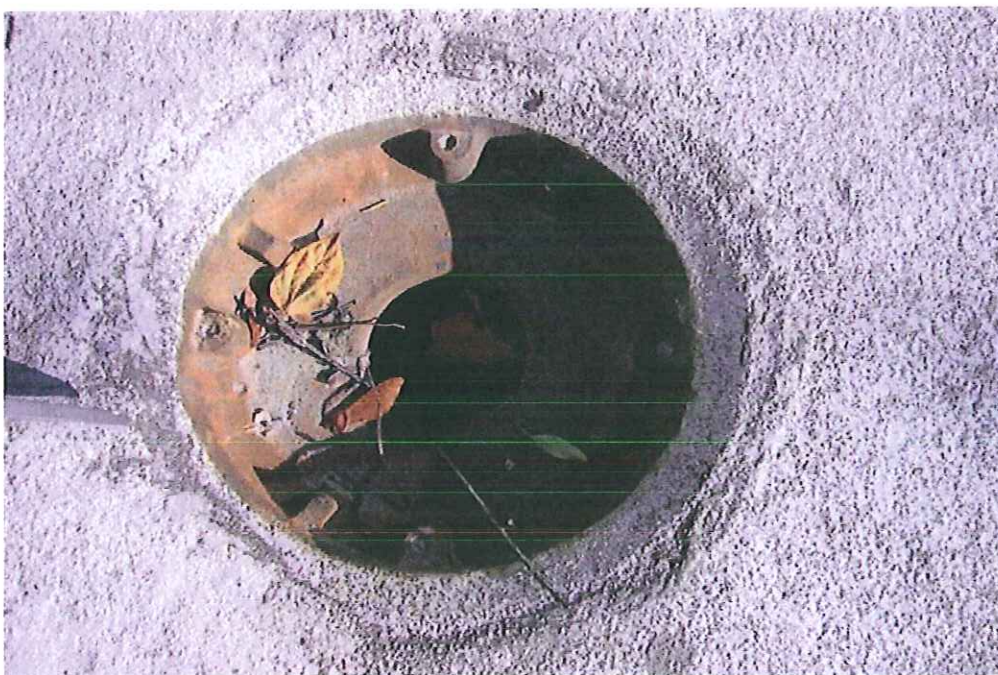
DRAINS

Drains on flat roof areas (area drains) are typically protected from foreign material by a perforated cover similar to a shower drain cover. If area drains become clogged, water can build up and leak into areas not intended to accommodate water. Many flat roof areas incorporate scupper drains through the perimeter parapet walls. These scupper drains are installed at a level above the area drains and are intended to relieve excess water in the event of an area drain backup only. Water that drains through the scupper drains simply spills down the face of the building, which could cause long-term damage; therefore area drains should be kept clear so that the relief scupper drains are not utilized.

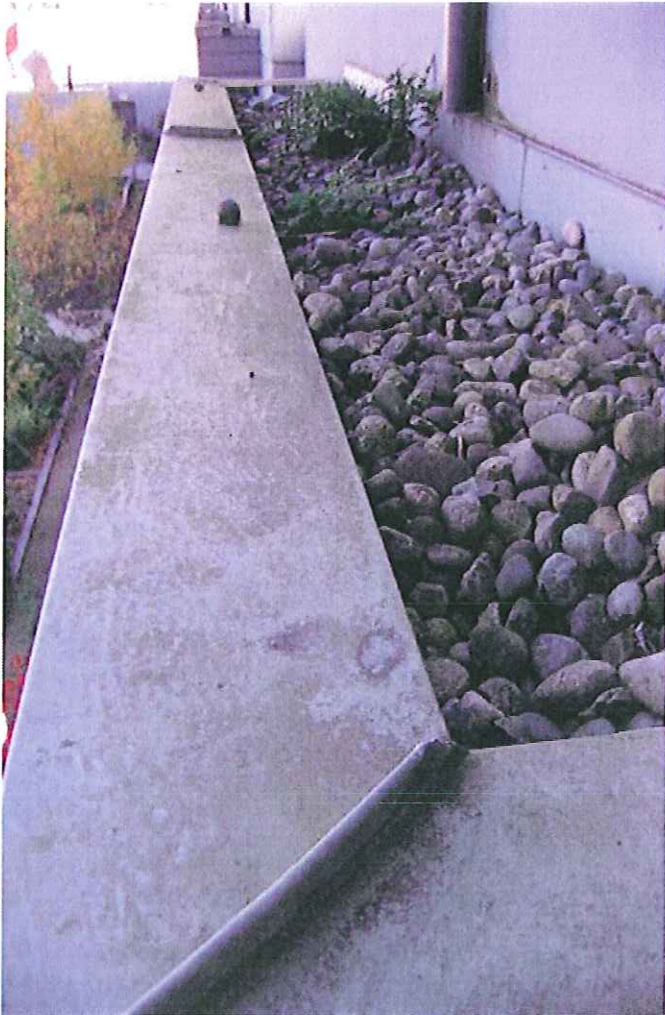
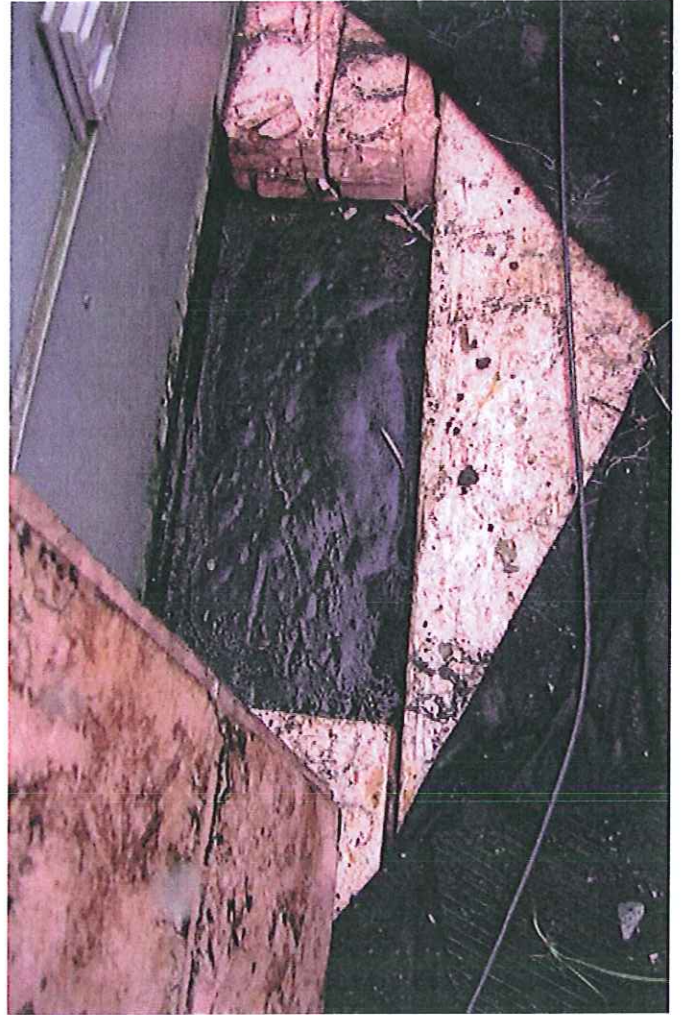
ROOFING SYSTEM

The roofs of The 501 are "inverted", indicating that the membrane is situated below the expanded polystyrene insulation. A ballast of river rock holds the insulation in place. These types of roof structures are robust as the membrane is protected from both U.V. degradation and severe heat fluctuations. During the condition survey, the roofing membrane was observed to be fabric-reinforced urethane, which in this configuration can have a life expectancy of 30 to 40 years.

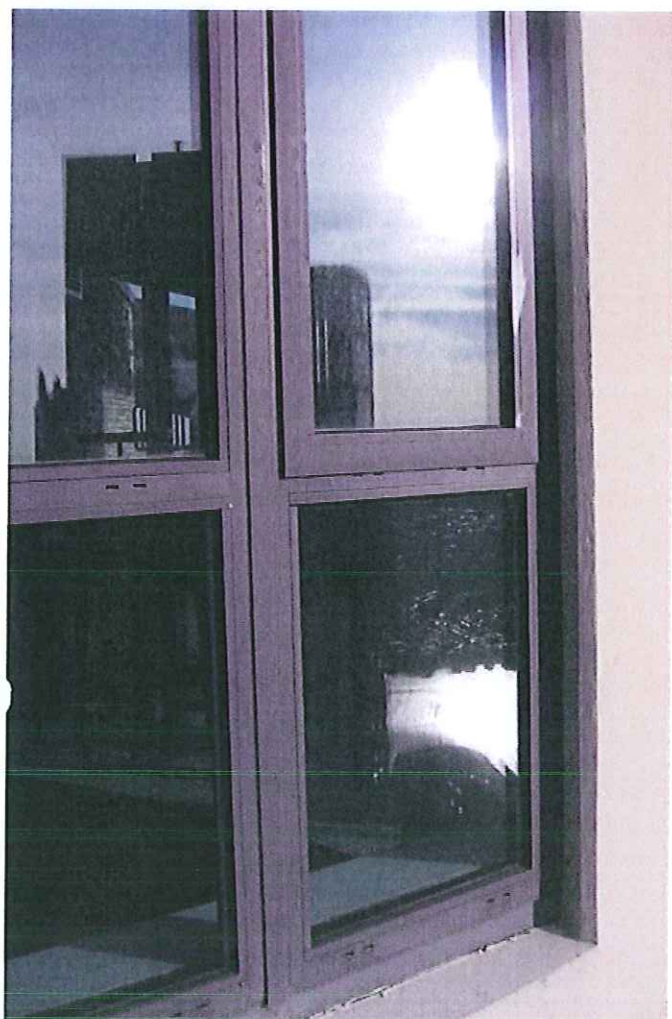
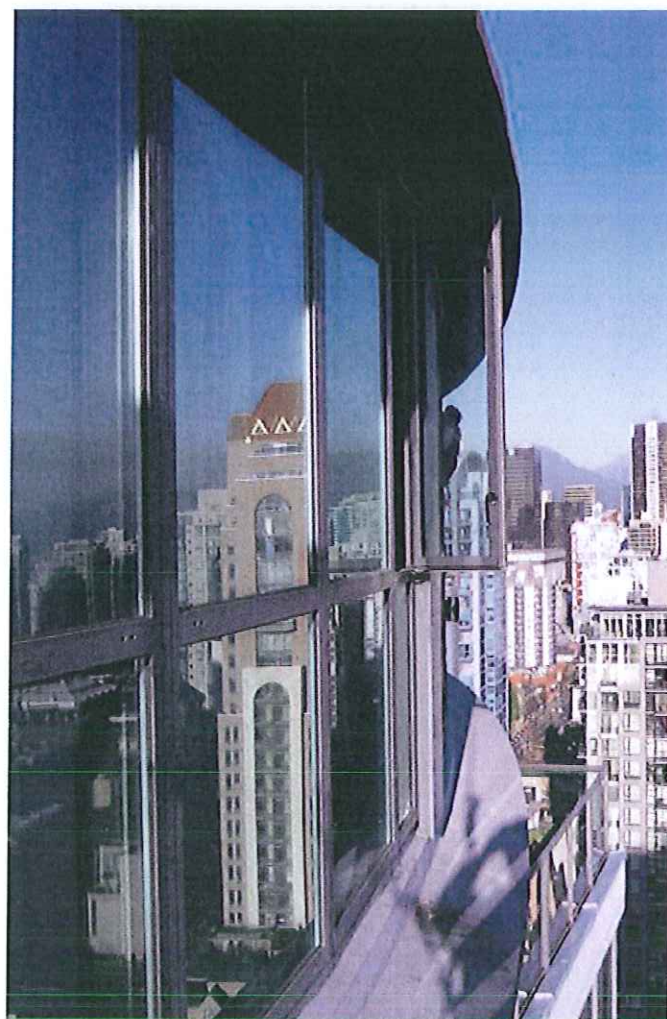
WINDOWS

All windows at The 501 incorporate hermetically sealed, insulated glazing units (IGU) often referred to as double-glazing. This is a system where two glass panes are sealed together with a thermal separation between them. This airtight seal prevents moisture accumulation between the glass panes so the unit does not fog up. The thermal separation improves the insulation properties of the glass, which reduces the probability of condensation forming on the interior during cold weather. These sealed units typically carry a 10-year guarantee from the manufacturer against failure of the seal, which have a normal life expectancy of between 20 and 40 years, depending on the size of the window and its exposure conditions.

The window frames at The 501 are of the aluminium thermally broken type. Aluminium window frames are generally joined together at their corners in a mitre joint and intermediate frame members held in place by screw fasteners through the perimeter frame. These areas are usually sealed at the time of manufacturing to prevent leaking.

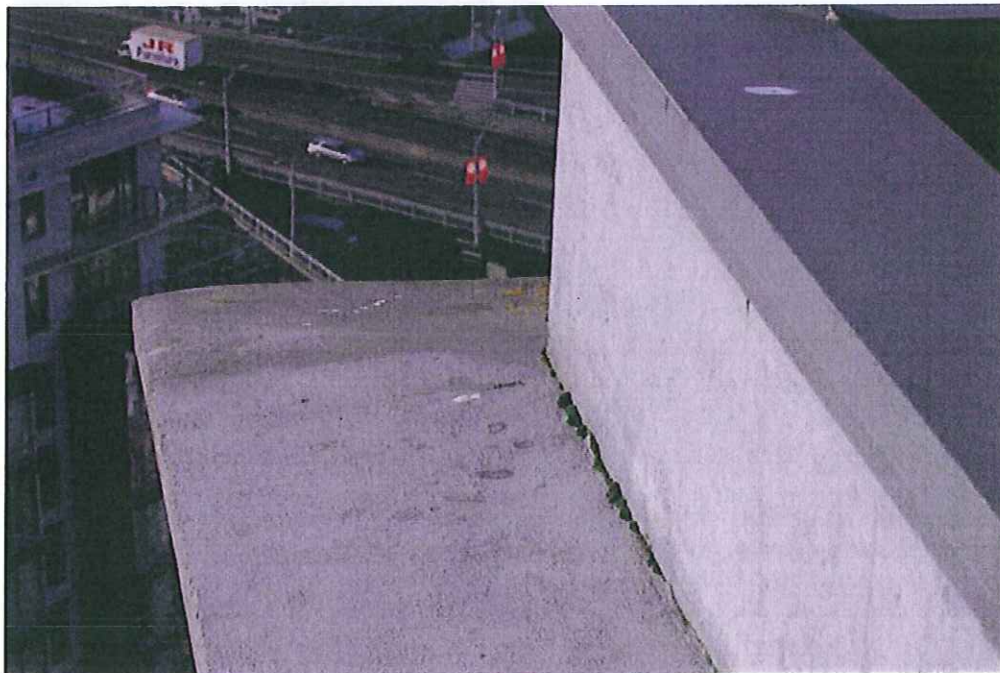
FLASHING

Flashings installed at The 501 are segmented and are connected with standing seam or 'S' lock joints. Joints, ends and edges of the flashings commonly utilize a sealant to assist with the control of moisture by providing a seal to adjacent materials. Many building failure problems are attributable in part to flashing problems, which allow concentrated amounts of water to penetrate the wall surfaces due to incorrect slope or inadequate seal to adjacent materials. For this reason it is critically important to the integrity of the roof and wall systems that the flashing slopes and sealant be maintained.

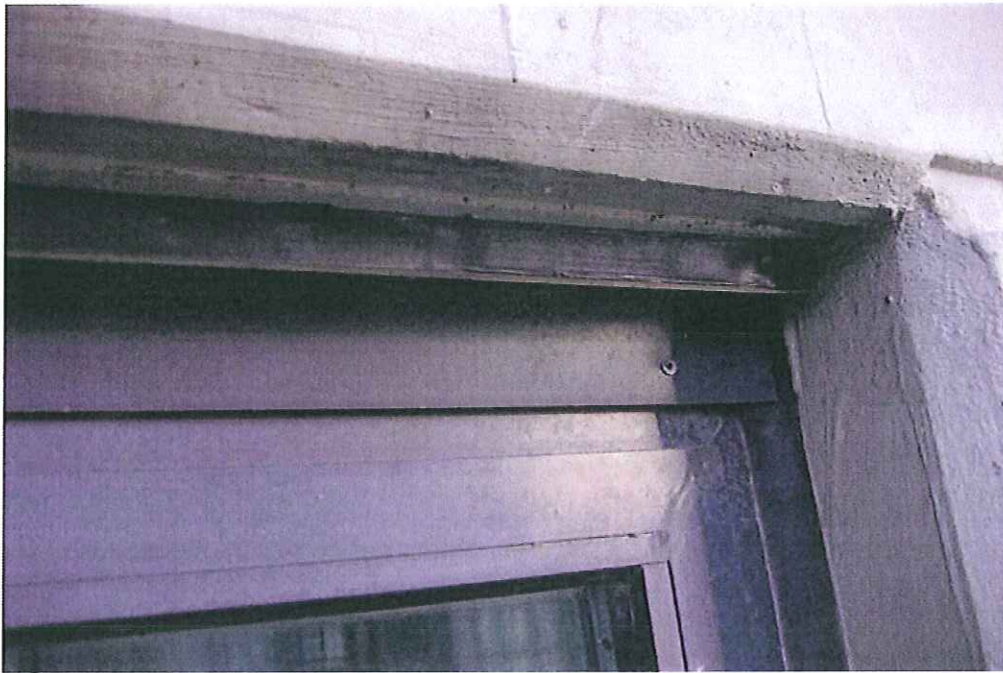
SEALANT

Sealant failure is not necessarily something that can be positively identified by a visual inspection. A caulk joint must often be subjected to an adhesion test to determine if it has lost its bond with the substrate. Caulking joints may appear to be failed to someone conducting a visual inspection because of a dark line at the edge of the sealant bead. This dark line results as dirt and/or mildew collects in the small gap that is formed by separation of the caulking from the substrate. This is a good indication that a failure is beginning, or has taken place.

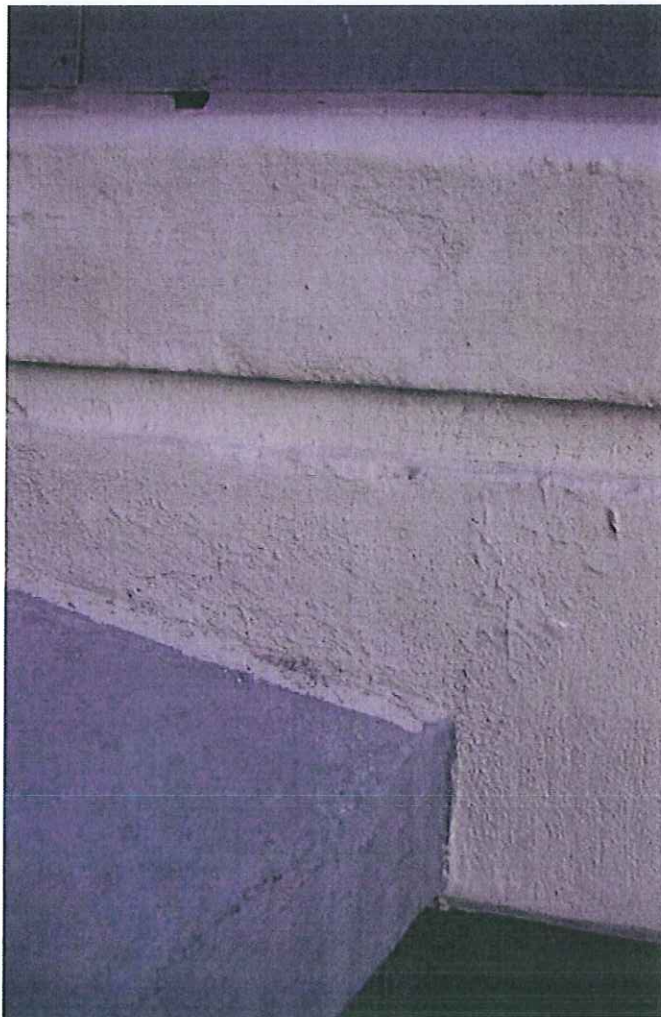
PAINT

Exterior acrylic latex paint has been used as the exterior coating of the cast in place concrete walls, balconies/soffits and eyebrow/slab-bands. This type of coating does not have the necessary physical properties to protect horizontal elements. As has been indicated in our Building Envelope Condition Survey, all such surfaces should be coated with a fabric reinforced urethane membrane.

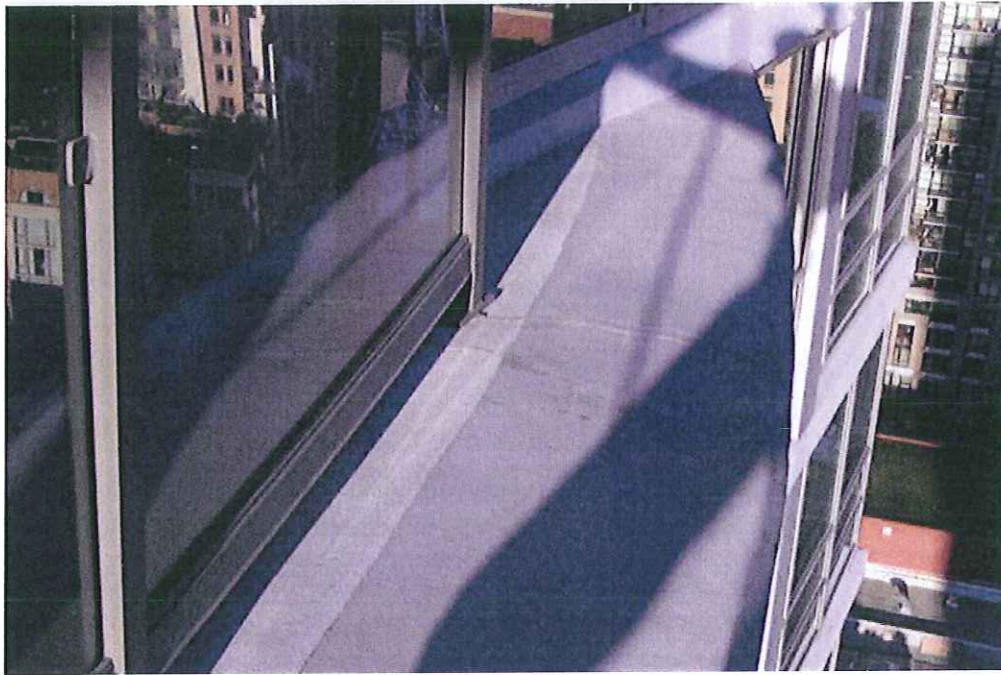
BALCONIES AND EYEBROWS

Spratt Emanuel Engineering Ltd. has recommended in our Building Envelope Condition Survey, that all balcony and eyebrow surfaces be protected with a new liquid applied urethane traffic membrane. Similarly to all other components of the building envelope, the new membrane will also require regular maintenance.

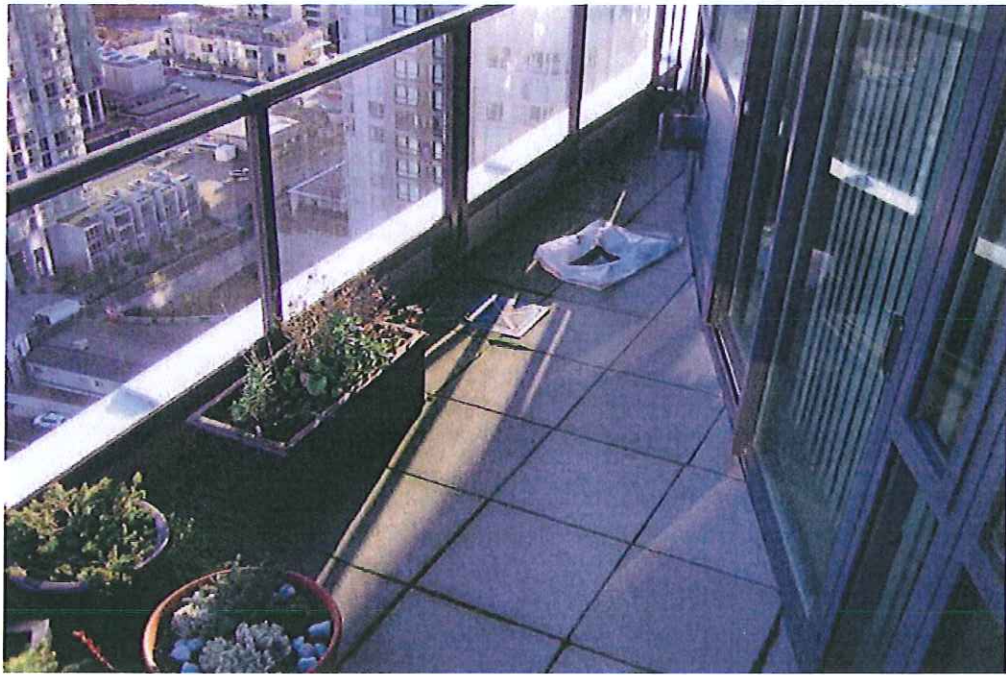
BALCONY/DECK GUARDRAILS AND PRIVACY SCREENS

The aluminum railings have an electrostatically applied paint finish, often referred to as a 'powder coating', which is installed by the manufacturer in a controlled environment. This type of paint finish resists cracking, chipping or peeling better than other types of paint finishes on aluminum products and is therefore commonly used on manufactured products. Tempered glass panes have been installed in the railings, which are supported by a rubber gasket or spline on the top and bottom. The glass panes can be easily removed by lifting them straight up and then pulling out at the bottom. The glass should be stored on a cushioned surface to protect against breakage. Tempered glass is susceptible to shattering if struck on its edge.

Maintenance of the aluminum railing should consist of cleaning to remove any mold, mildew or foreign matter. A visual inspection should also be done whenever deck areas are being cleaned in order to assess the condition of the sealant used around the screws, fastening plates which secure the top mounted privacy screens of the townhouses. Proper replacement of failed sealant may necessitate removal of the railings.
